INDOOR AIR QUALITY ASSESSMENT

**Mary K. Goode Elementary School
31 Mayflower Avenue
Middleborough, Massachusetts**

Prepared by:
Massachusetts Department of Public Health
Center for Environmental Health
Bureau of Environmental Health Assessment
Emergency Response/Indoor Air Quality
January 2005

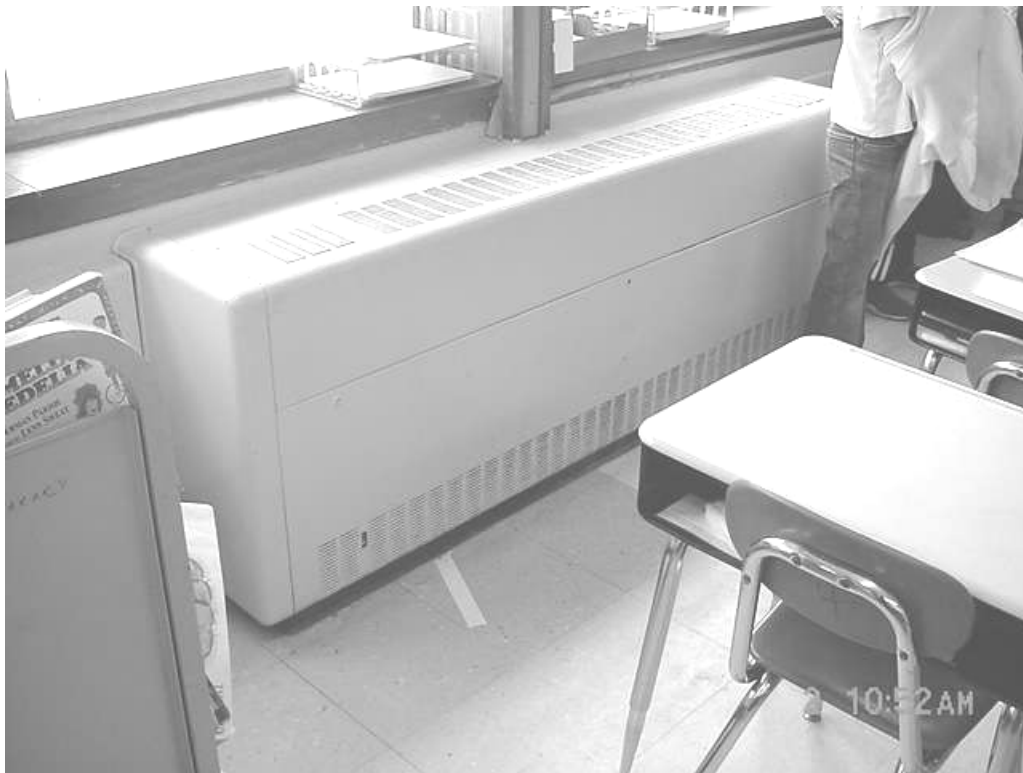
Picture 1

Fresh air is supplied to classrooms by a unit ventilator (univent) system (Picture 1). A univent draws air from outdoors through a fresh air intake located on the exterior wall of the building (Picture 2) and returns air through an air intake located at the base of the unit ([Figure 1](#)). Fresh and return air are mixed, filtered, heated and provided to classrooms through an air diffuser located in the top of the unit. A number of univents

Classroom Univent

3. Survey classroom univents to ascertain function and determine whether an adequate air supply exists for each room. Consider consulting a heating, ventilation and air conditioning (HVAC) engineer concerning the calibration of univent fresh air control dampers throughout the school.

4. Operate all ventilation systems throughout the building (e.g., gym, auditorium, classrooms) continuously during periods of school occupancy and independent of thermostat control to maximize air exchange. To increase airflow in classrooms, set univent controls to “high”.

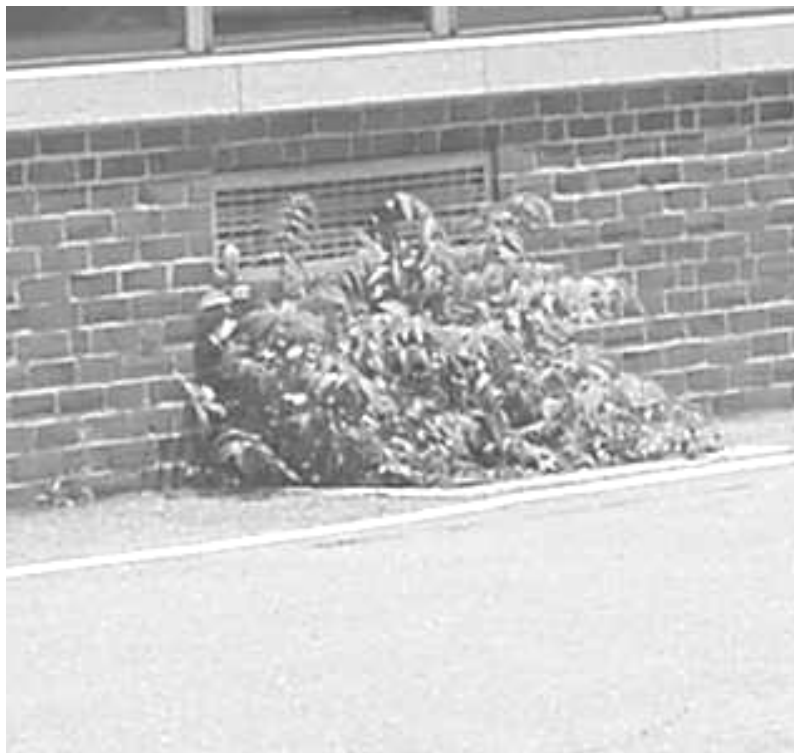
Picture 2

Plants were located in front of univent air intakes and/or near univent air diffusers (Pictures 2 and 3). Plants, soil and drip pans can serve as sources of mold growth. Over-watering of plants should be avoided and drip pans should be inspected periodically for

Univent Fresh Air Intake, Note Proximity of Shrubbbery

12. Remove foliage to a minimum of five feet away from the foundation. Trim trees in rear of building that overhang the roof. Ensure univent air intakes on the exterior of the building are free of obstruction.

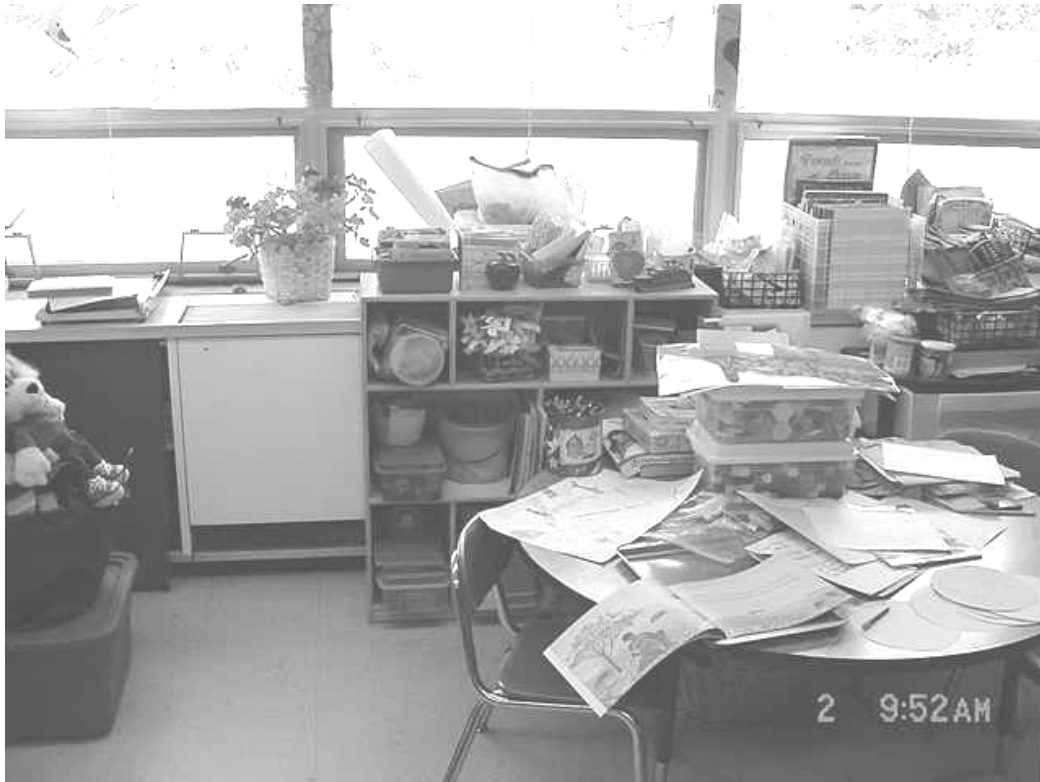
Picture 3

were deactivated during the assessment (Table 1). Obstructions to airflow, such as papers and books stored on univents and items placed in front of univent returns, were seen in a number of classrooms (Picture 3). In order for univents to provide fresh air as designed, these units must remain activated and allowed to operate while rooms are occupied. In addition, univent intakes and diffusers must remain free of obstructions.

Book Case in Front of Univent Return and Items on Top of Univent Air Diffuser

5. Inspect rooftop exhaust motors and belts for proper function, repair and replace as necessary.
6. Remove all blockages from univents and exhaust vents to facilitate airflow.

13. Move plants away from univents in classrooms. Ensure all plants are equipped with drip pans. Examine drip pans for mold growth and disinfect areas of water leaks with an appropriate antimicrobial where necessary. Consider moving the duplicating equipment to an area that has exhaust ventilation or examine the feasibility of providing local mechanical exhaust ventilation.

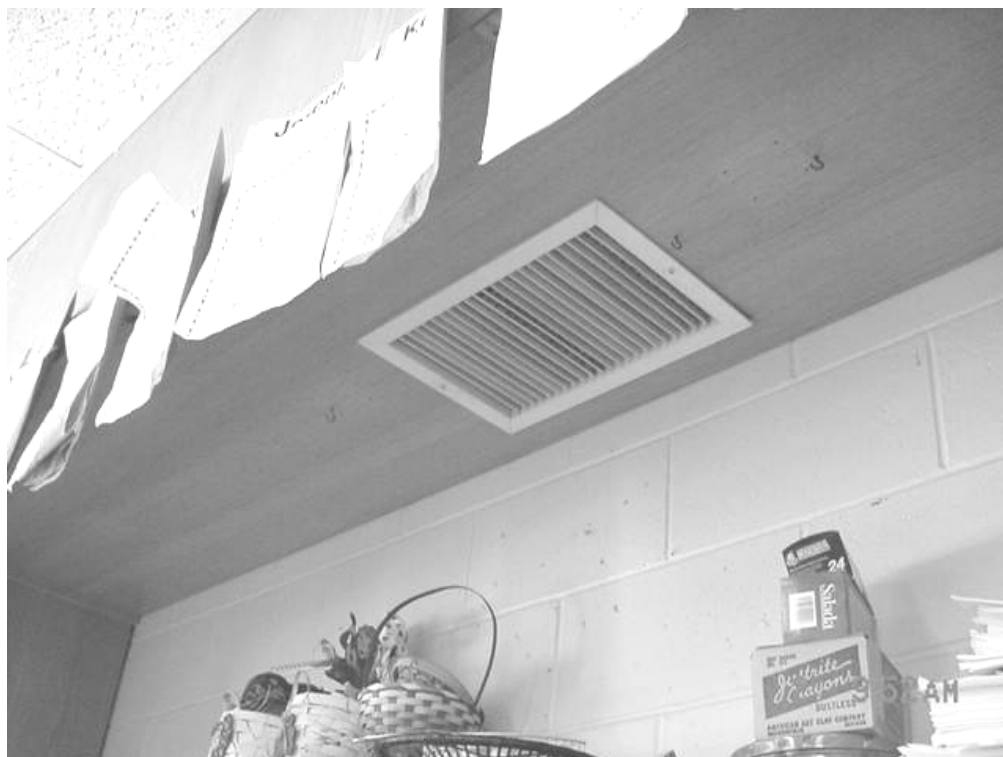
Picture 4

Mechanical exhaust ventilation is powered by rooftop fans. Exhaust vent grilles are located in the ceilings of coat closets (Picture 4). Air is drawn into the classroom coat closet via undercut doors (Picture 5). The exhaust system was either not functioning or drawing weakly in several areas surveyed, indicating that motors were deactivated or non-functional (Table 1). The location of these vents inside closets allows them to be easily blocked by stored materials (Pictures 6 and 7), thereby restricting airflow. As with the univents, exhaust vents must be activated and remain free of obstructions in order to function as designed. Without sufficient supply and exhaust ventilation, environmental pollutants can build up, leading to indoor air quality/comfort complaints.

Exhaust Vent in top of Coat Closet

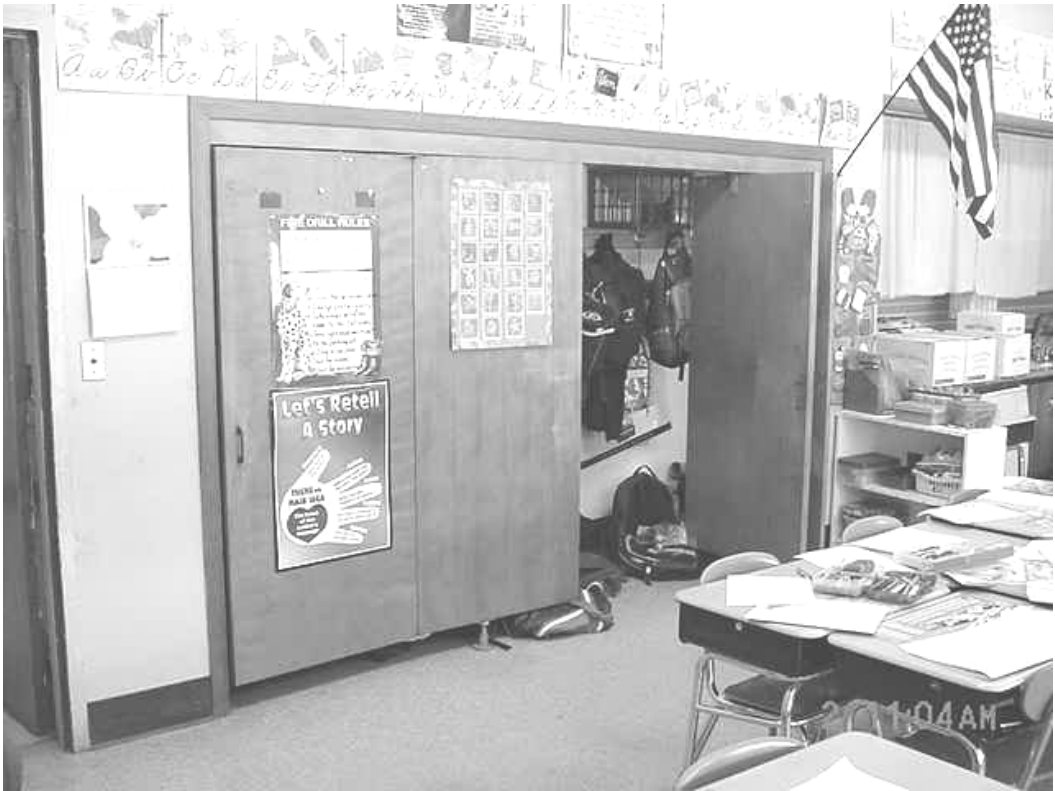
Picture 5

Undercut Coat Closet Doors

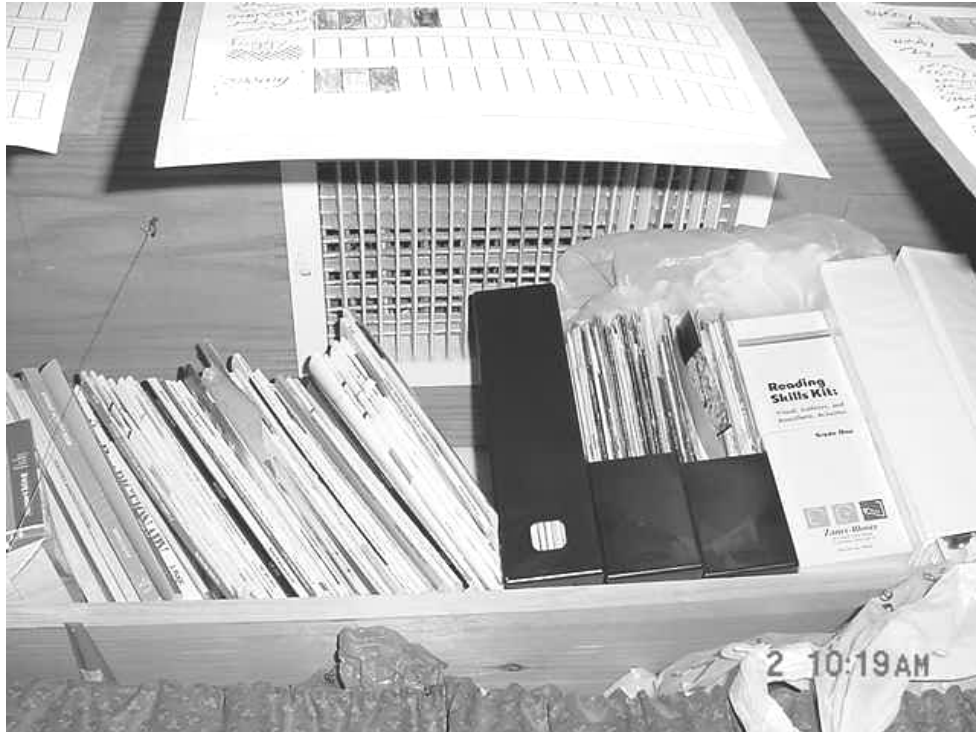
Picture 6

Obstructed Coat Closet Exhaust Vent

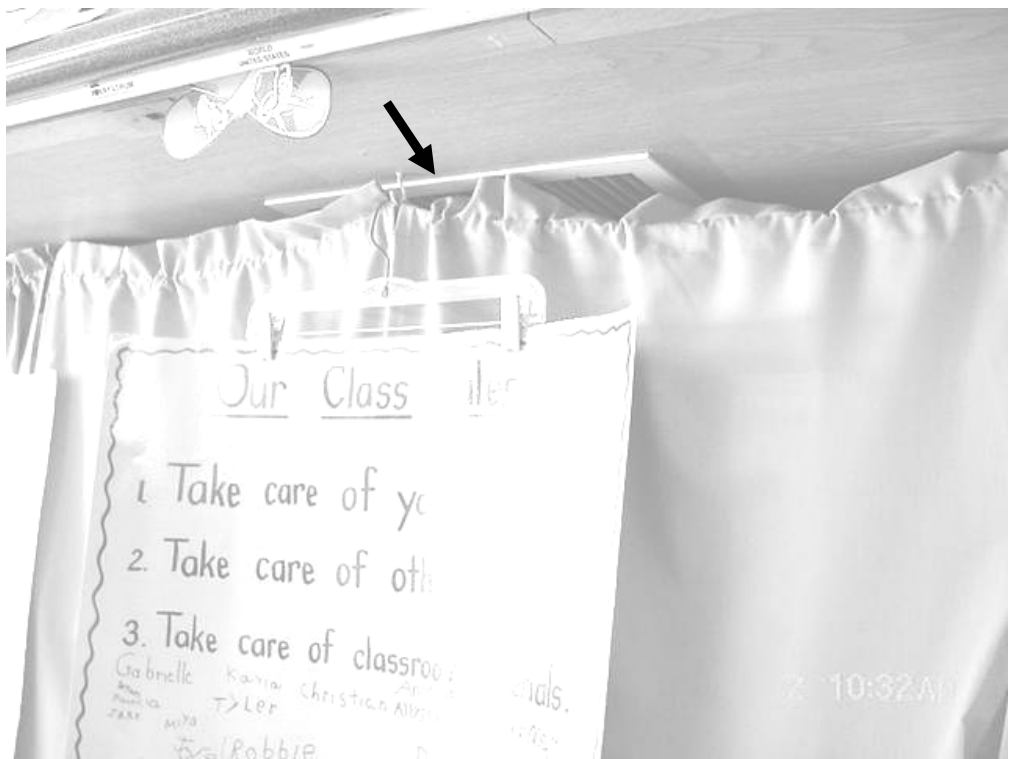
Picture 7

Coat Closet Exhaust Vent Obstructed by Curtain

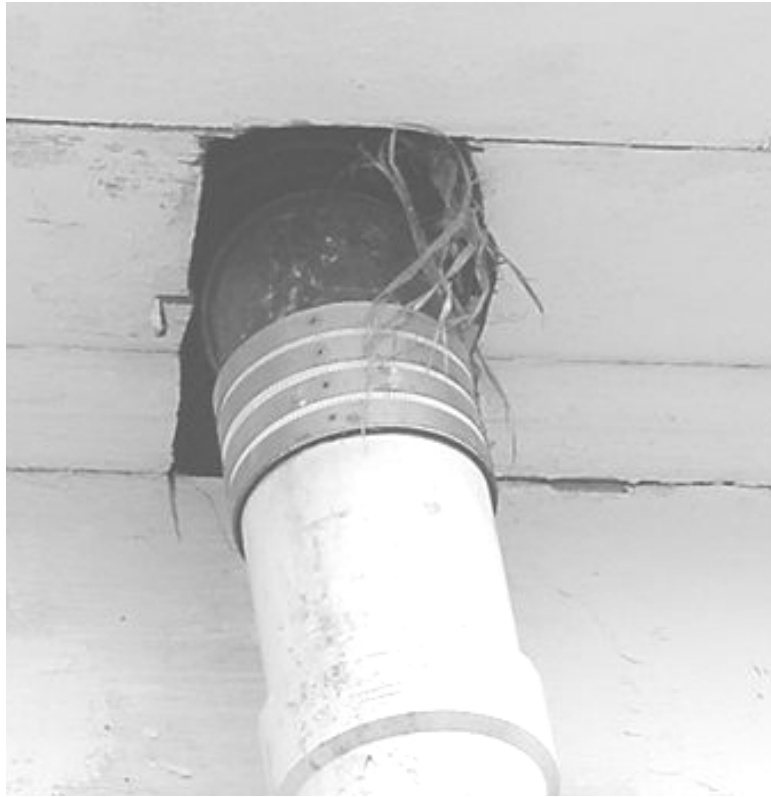
Picture 8

Signs of bird roosting and nesting were observed in a number of recesses around the building exterior (e.g., overhangs, building envelope penetrations for downspouts/roof drains) (Pictures 8 and 9). Birds can be a source of disease, and bird wastes and feathers can contain mold, which can be irritating to the respiratory system.

Bird Nesting Materials in Roof Overhand around Downspout/Roof Drain

1. Install a digital readout thermometer in the hallway outside of the boiler room and monitor daily. Have boiler serviced to ensure adequate amount of combustion air for fuel.
2. Contact a building contractor to seal building envelope penetrations and/or a pest management consultant to remove birds' nests and wastes from the building. To prevent possible exposure to bird wastes, implement the corrective actions recommended by the CDC (CDC, 1998). To prevent possible spread of bird waste particulates to occupied areas, employ the methods listed in the SMACNA guidelines for Containment of Renovation in Occupied Buildings (SMACNA, 1995).

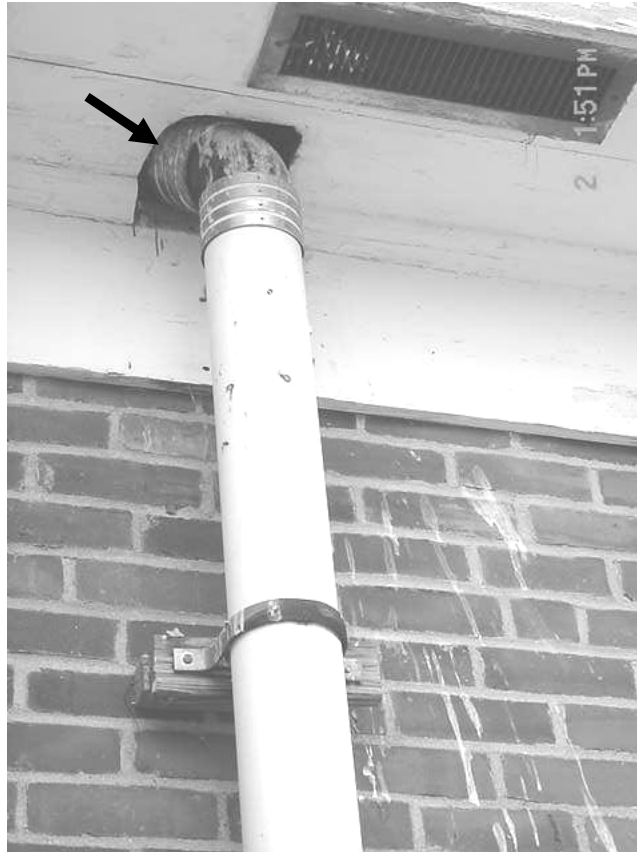
Picture 9

Bird Feces on Downspout and Exterior Wall

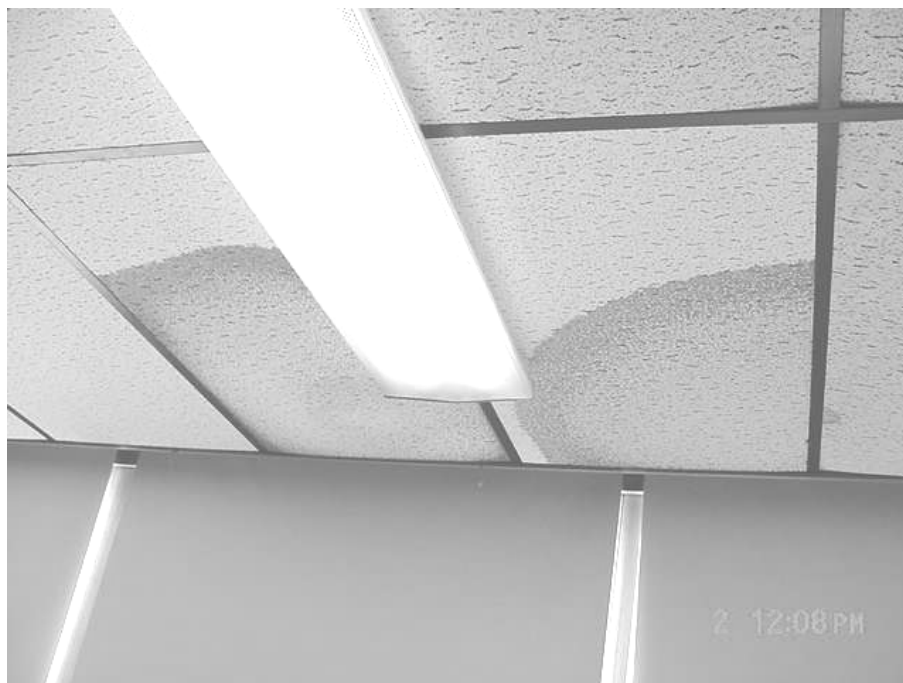
Picture 10

School department officials reported that the building had active roof leaks and that funding for roof repair is part of a planned capital repair project. Water damaged ceiling tiles were observed in a number of areas throughout the building (Picture 10). Water-damaged ceiling tiles can provide a source of mold growth and should be replaced after a water leak is discovered and repaired.

Water Damaged Ceiling Tiles

9. Continue with plans for roof repair/replacement. Replace any water-damaged ceiling tiles, once leaks are repaired. Examine the area above and beneath these areas for

- microbial growth. Disinfect areas of water leaks with an appropriate antimicrobial. Clean areas of antimicrobial application when dry.
10. Make repairs to gutters/downspouts to direct rain water away from the building.

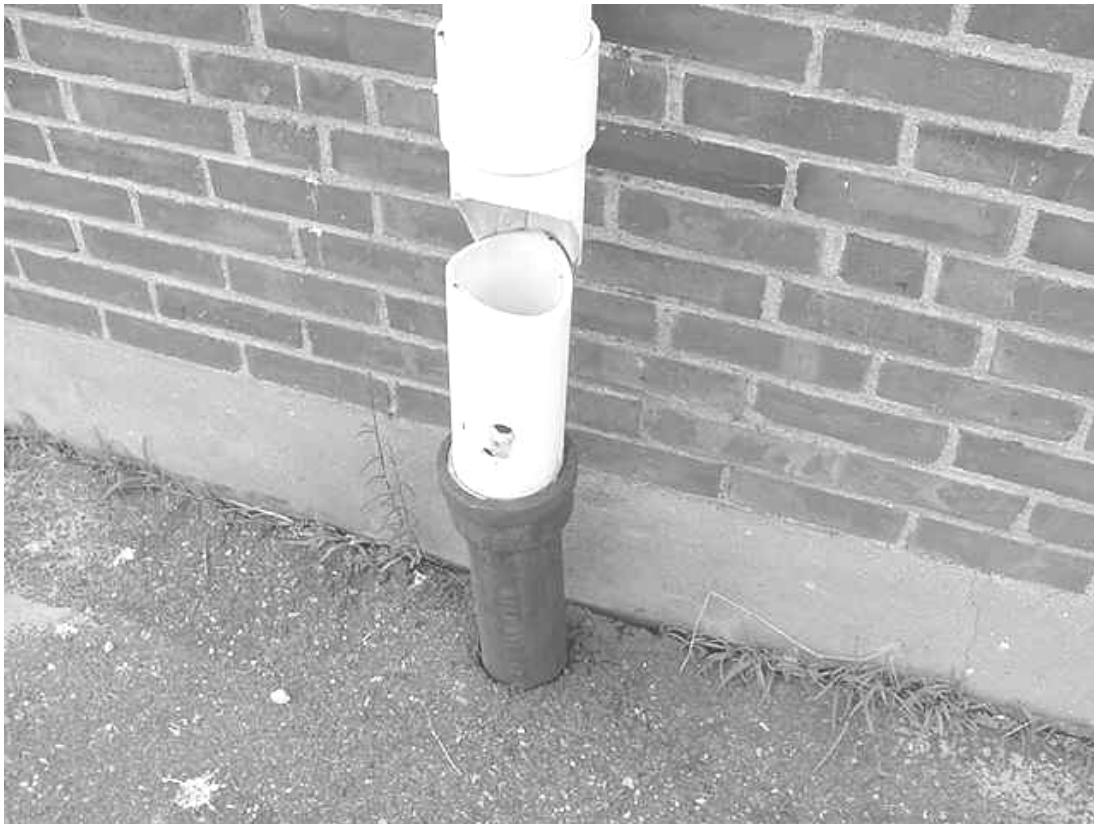
Picture 11

BEHA staff examined the building exterior and observed several downspouts that were damaged and/or clogged (Pictures 11 and 12). Excessive exposure of exterior brickwork to water can result in damage over time. During winter weather, the freezing and thawing of moisture in bricks can accelerate the deterioration of brickwork and become a point of water intrusion.

Damaged Downspout

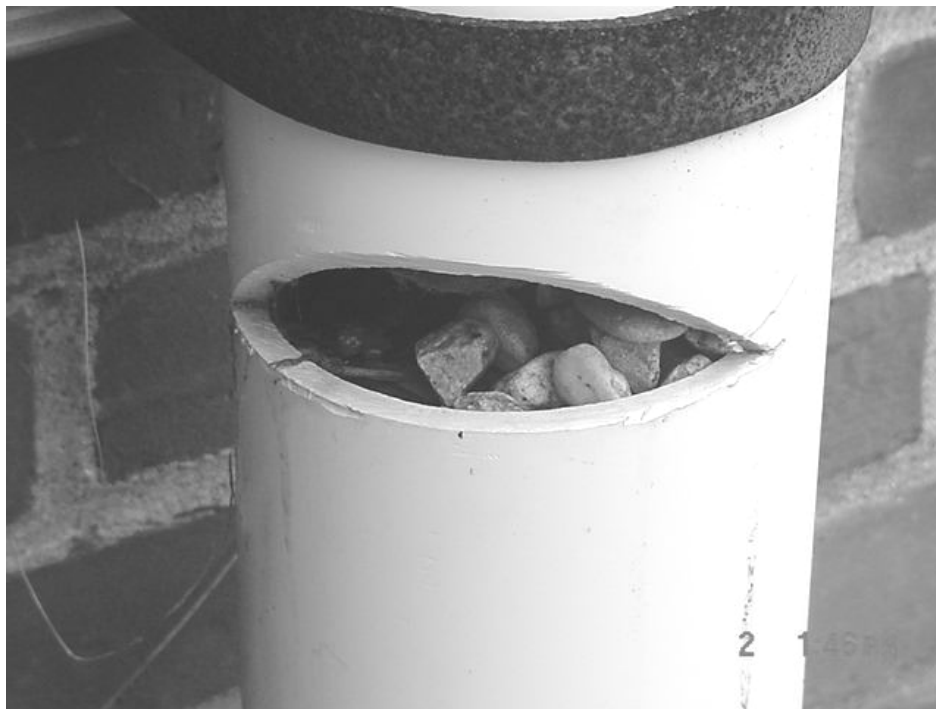
Picture 12

Downspout Clogged With Rocks

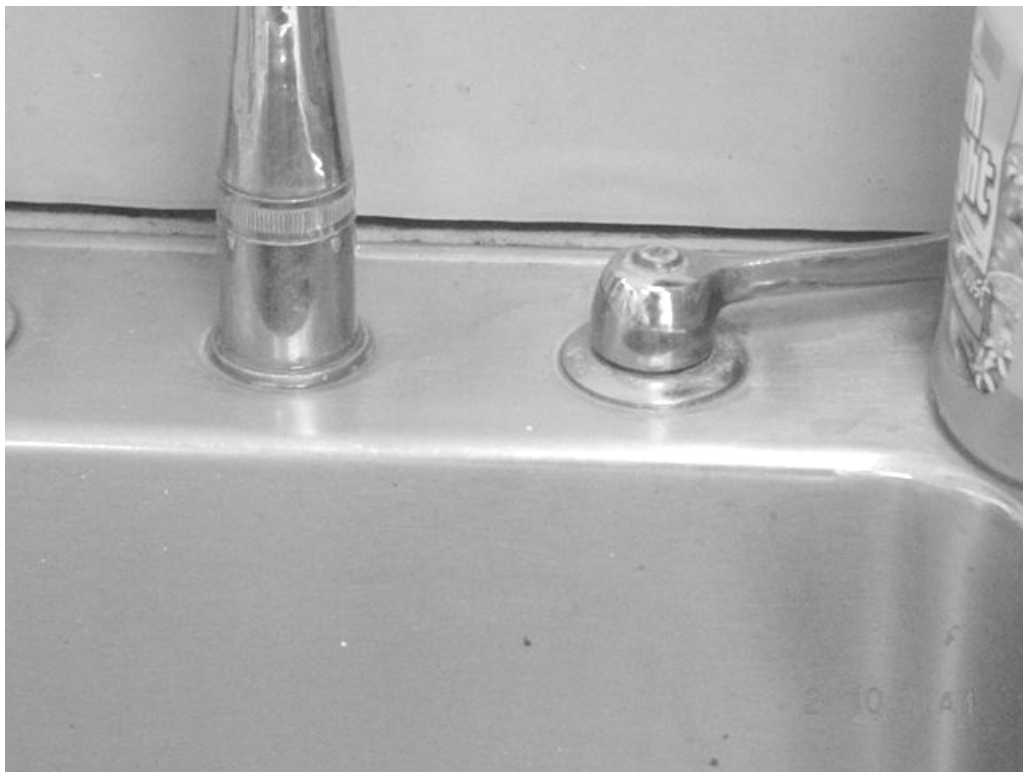
Picture 13

Spaces between the sink countertop and backsplash were noted in several classrooms (Picture 13). Improper drainage or sink overflow can lead to water penetration of the countertop, the cabinet interior and areas behind cabinets. Like other porous materials, if these materials become wet repeatedly they can provide a medium for mold growth.

Space between Sink Countertop and Backsplash

11. Replace missing or damaged caulking between countertops and sinks. Observe interior of cabinets for water-damage and mold growth. Disinfect with an appropriate antimicrobial where necessary.

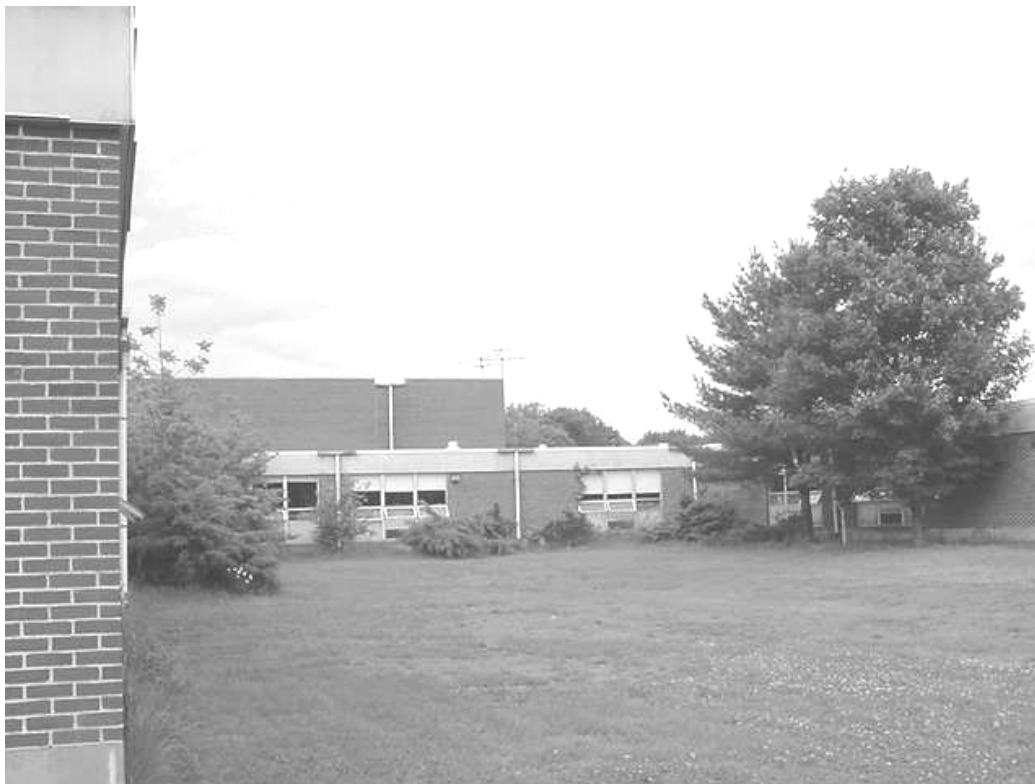
Picture 14

Shrubbery and other plants were also seen growing in close proximity to exterior walls (Picture 14). The growth of roots against the exterior walls can bring moisture in contact with wall brick. Plant roots can eventually penetrate the brick, leading to cracks and/or fissures in the below ground level foundation. Over time, this process can undermine the integrity of the building envelope, providing a means of water entry into the building through capillary action through foundation concrete and masonry (Lstiburek & Brennan, 2001).

Trees against Exterior Walls and over Roof

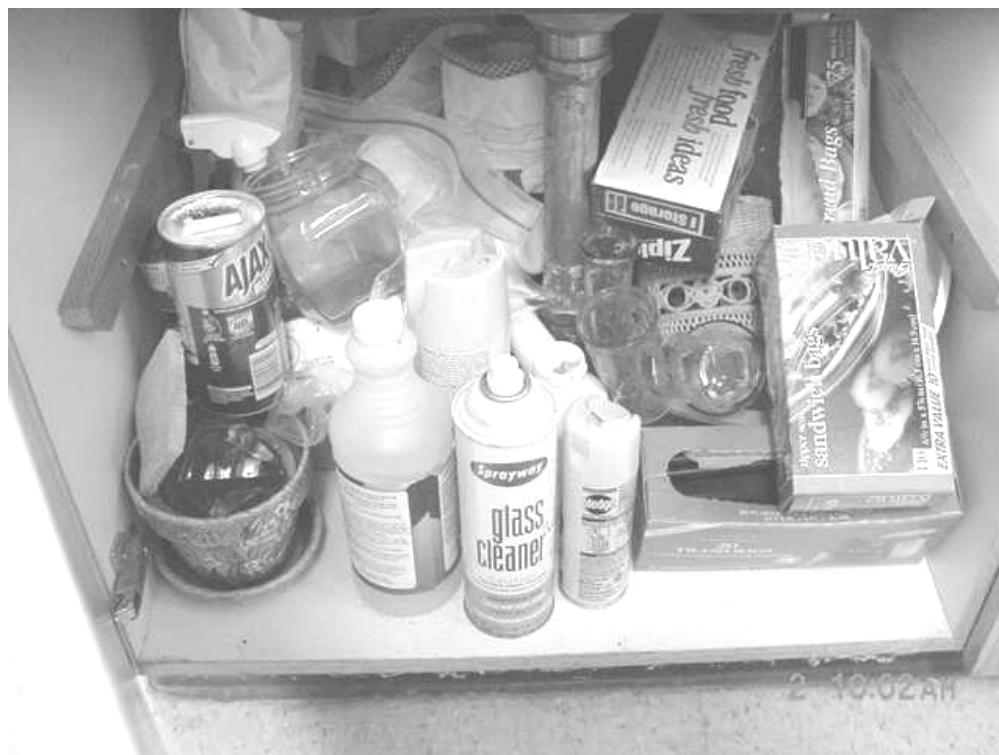
Picture 15

Cleaning Products under Sink in Classroom

20. Store cleaning products properly and out of reach of students. Ensure spray bottles are properly labeled in case of emergency. Remove flammable materials from classrooms and store in flammable storage locker.

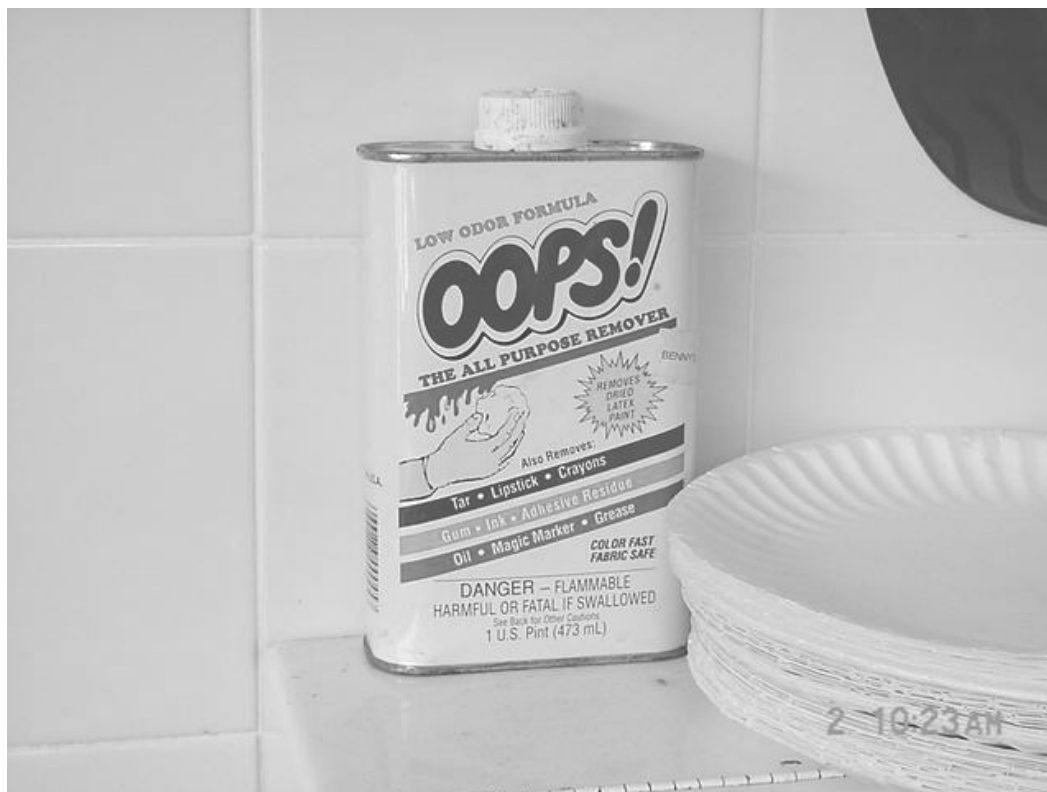
Picture 16

Please note, TVOC air measurements reported are only reflective of the indoor air concentrations present at the time of sampling. Indoor air concentrations can be greatly impacted by the use of TVOC containing products. While TVOC levels were ND, materials containing VOCs were present in the school. Spray-cleaning products were found on countertops and in unlocked storage cabinets beneath sinks in classrooms (Picture 15). Cleaning products contain chemicals that can be irritating to the eyes, nose and throat. One classroom contained a flammable all-purpose cleaner, which read “harmful or fatal if swallowed” (Picture 16). Cleaning products should be stored properly and kept out of reach of students. Flammable materials should be kept in a flammables locker approved by the National Fire Protection Agency (NFPA).

Flammable Material in Classroom Labeled Harmful or Fatal if Swallowed
